# Town of Paonia

## Street Inventory Report

January 2021  
Colorado State Forest Service

## **2020 Street Tree Inventory**

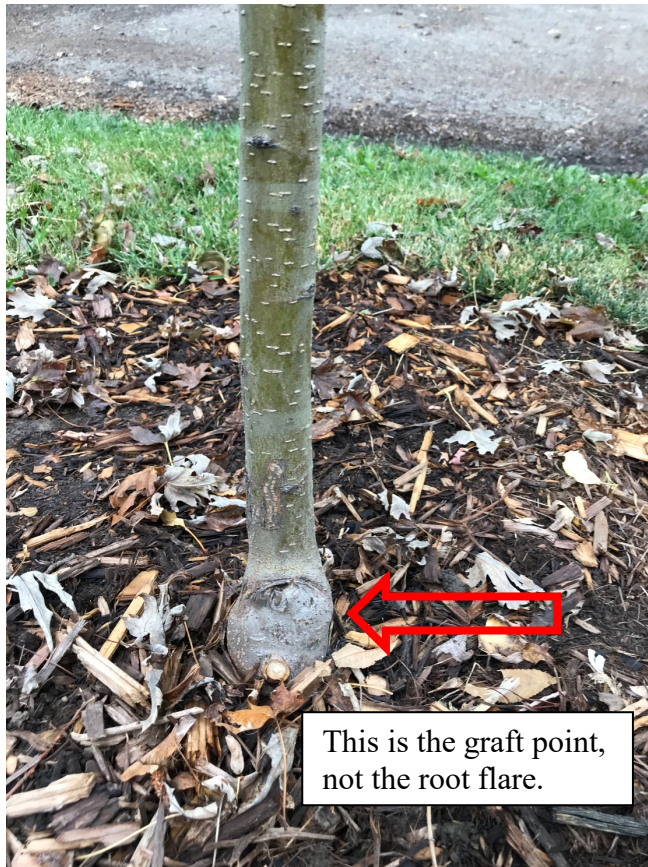
Planting issues were identified in the Town during the inventory. The main concern was that both container and ball and burlap trees are being planted too deep in the ground and in holes that are too small. Education of the proper planting steps to staff and contractors will minimize the issue in the future. Additionally, it is

Image 1. A recently planted tree, it was planted too deep in the soil. No root flare is visible.

recommended that the Town insert wording in future planting contracts that require the landscaping company to follow proper planting standards. The existing planted trees with these issues will need to be addressed as time and money allow for it. The CSFS is willing to conduct training for Town staff and contractors and review contract wording to ensure proper planting is done in future planting projects.

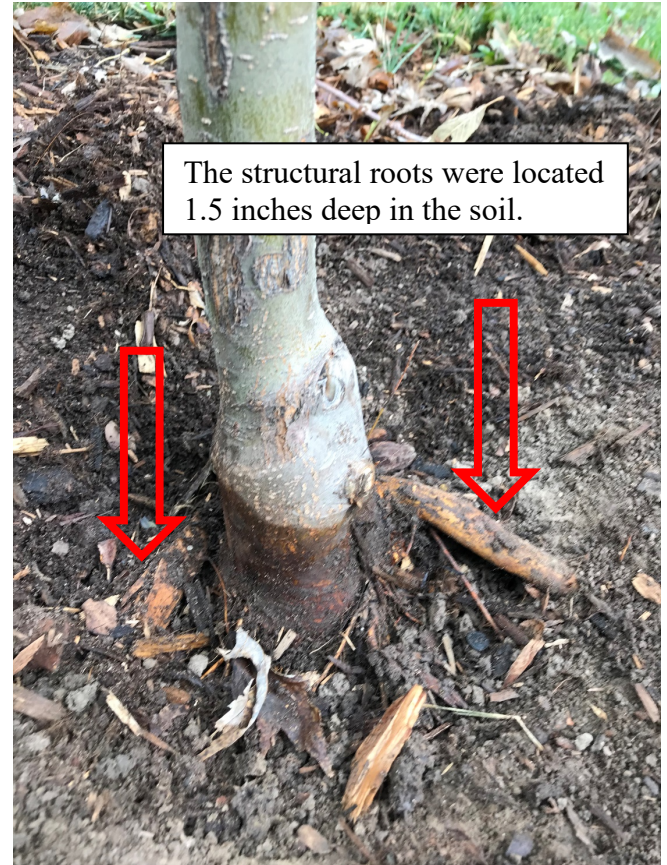
Image 2. The root flare was excavated and was found approximately 1.5 inches deep.

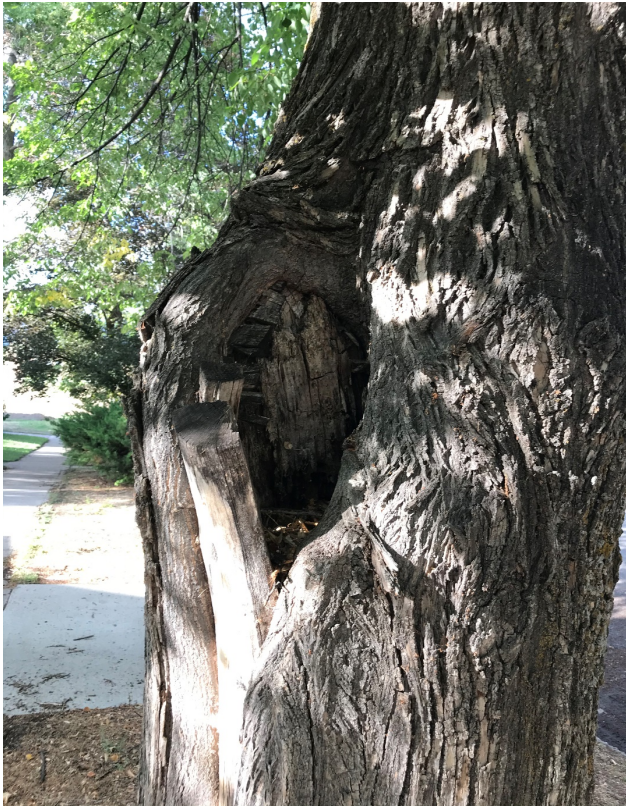
Minimal insect and disease activity was observed during the inventory as 65 percent of trees showed no pest activity. **Decay** was the most commonly identified disease with 52 trees (10% of trees) showing signs of compromised wood integrity. According to the Morton Arboretum, "once a wound occurs, decay-causing fungi can enter the heartwood and the decay process begins. Trees have a unique defense. The wood around the wound begins to produce special compounds in the wood cells that set up a wall or barrier to isolate the

Image 3. Decay in trunk from an old pruning wound.

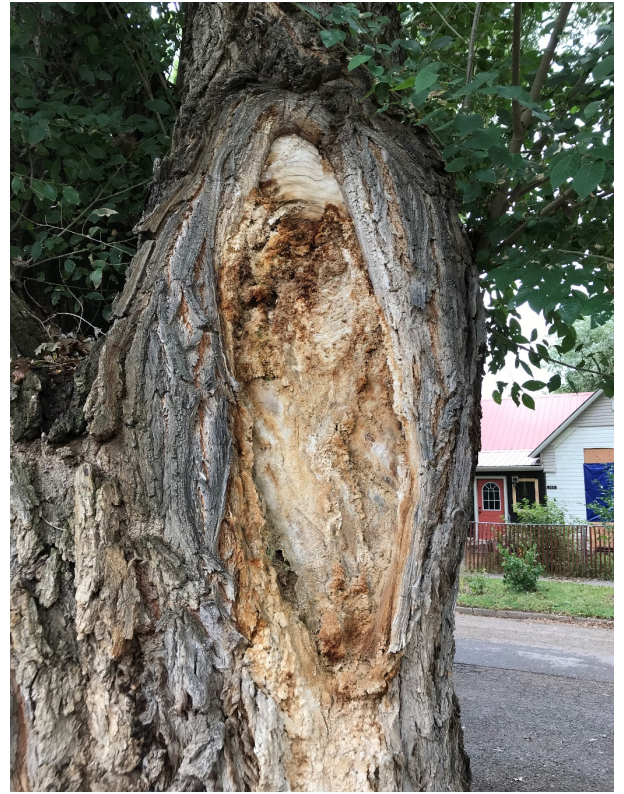
The second most commonly observed pest was **bacterial wetwood** in both Siberian elm and various cottonwood species (34 trees, 6.6%). The Morton Arboretum states “wetwood, also known as slime flux, is a very common bacterial disease that occurs in many kinds of trees. Nearly all elm and poplar species are affected, as are numerous other trees including crabapple, birch, maple, horse chestnut, linden, oak, pine, redbud, and sycamore. Wetwood is normally not a serious disease. However, a tree with a chronic case of wetwood may decline in general vigor.” (www.mortonarb.org) The outward signs of wetwood is a dark brown to black water-soaked area of wood, usually seen around cracks in the bark and old pruning cuts. The liquid itself is pale and when it dries it can leave a pale gray to white crust on the bark, see Image 4. There is no control for wetwood and it usually does not require management. If a high-quality tree is infected with wetwood and is showing signs of dieback or decline, a drainpipe for the fluid may be installed but this would only be done in extreme cases.

Image 4. Bacterial wetwood visible on a poor pruning cut on a Siberian elm.

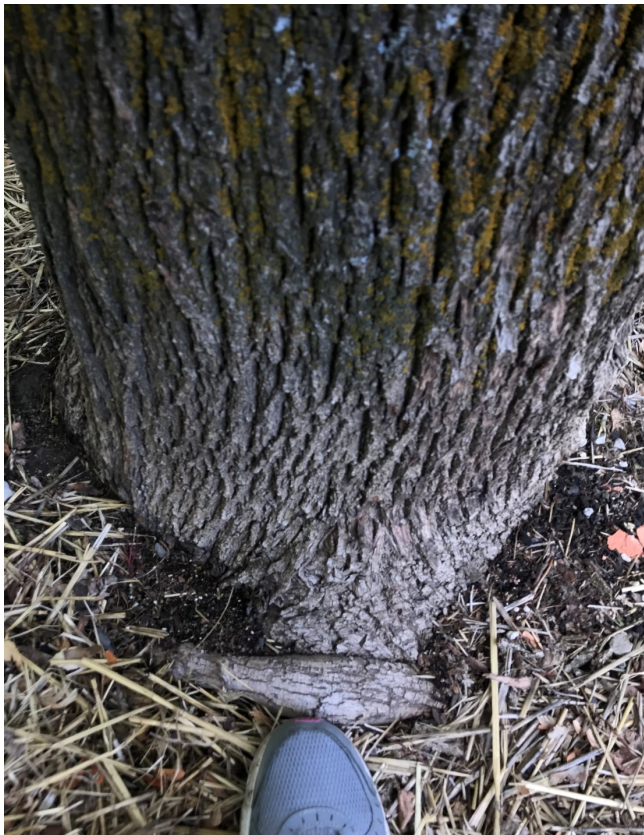
Image 5. Girdling root that should be removed.

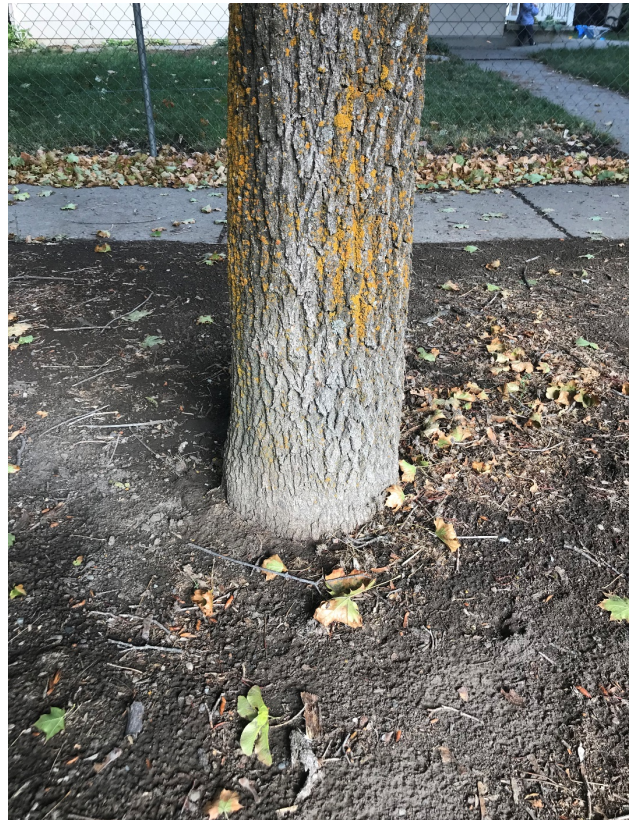
Image 6. Tree with no root flare, excavate to locate and expose root flare.

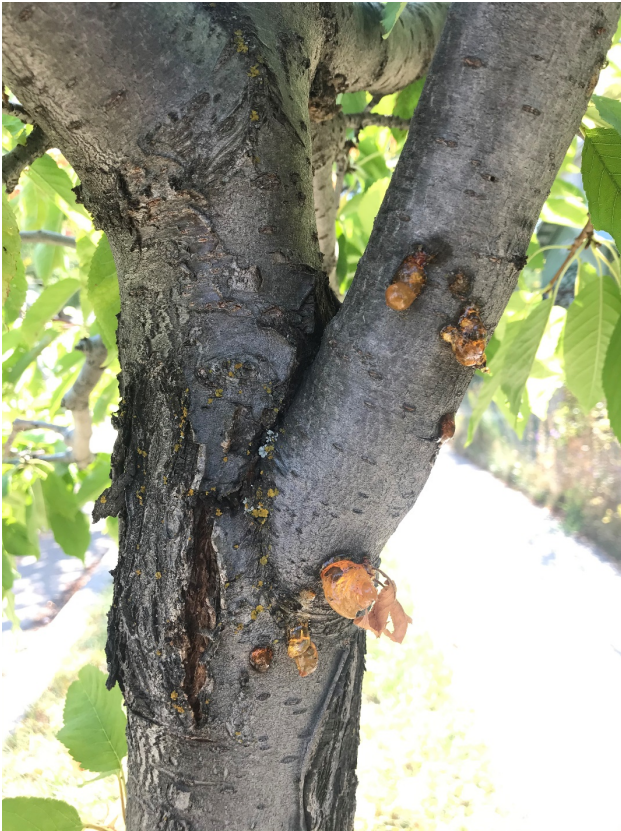
Image 7. Cherry tree with Cytospora canker resin.

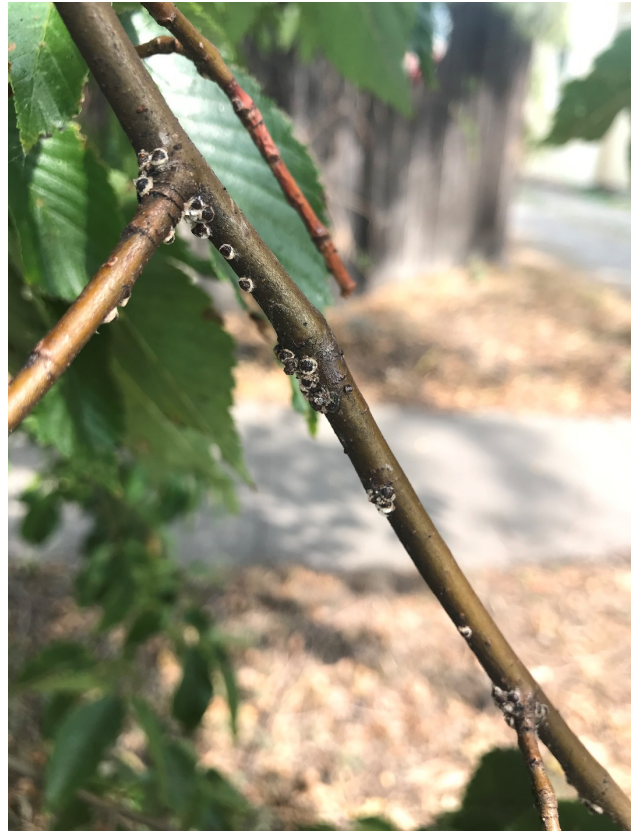
Image 8. European elm scale on an American elm.

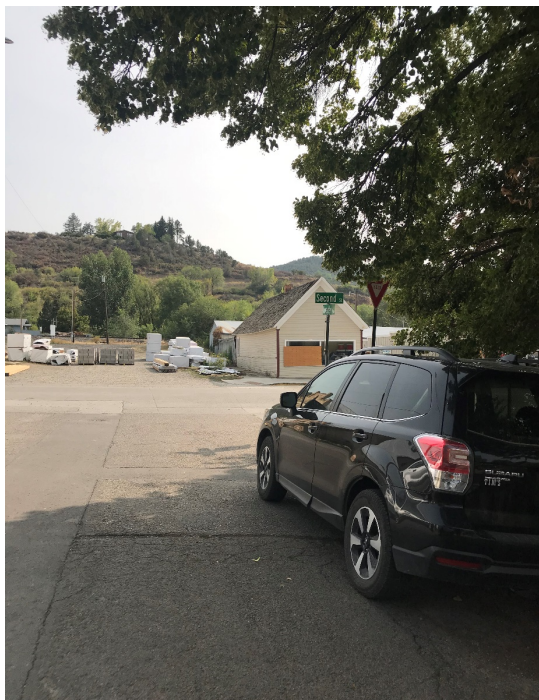
Image 10. This tree on 2<sup>nd</sup> and Boxelder is beginning to block the yield sign and needs to have the crown lifted.

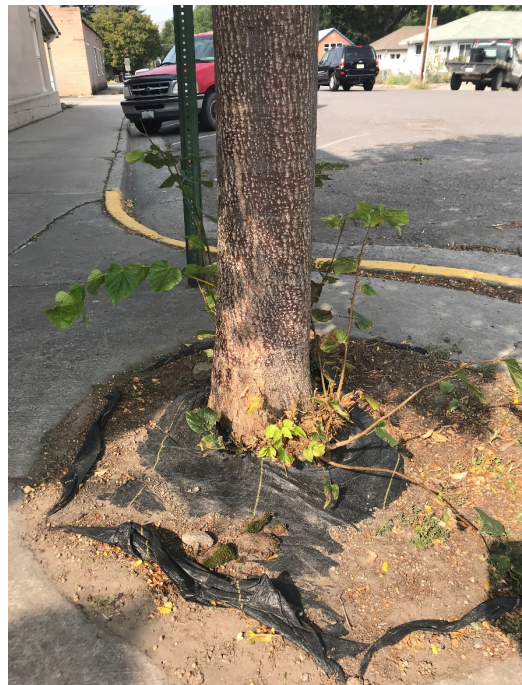
Image 11. This linden tree on 2<sup>nd</sup> and Grand needs to have its root collar excavated, and the suckers and fabric removed.

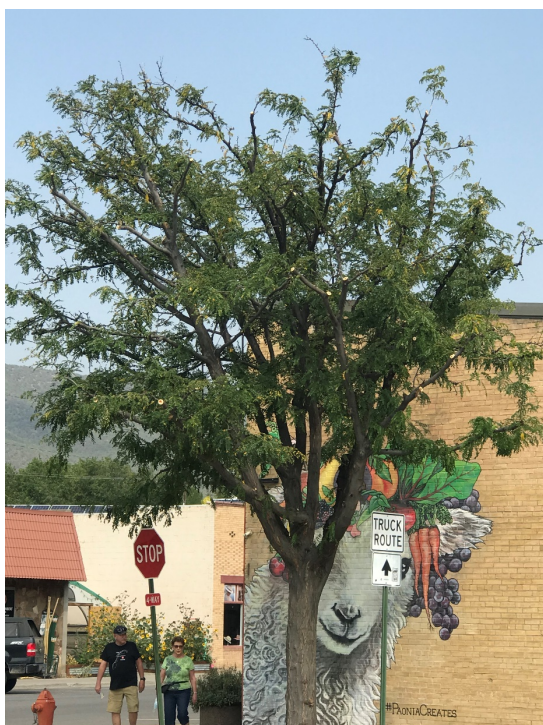
Image 12. This honeylocust needs to have structure pruning to restore its crown after being improperly pruned in the past. Also located on 2<sup>nd</sup> and Grand.

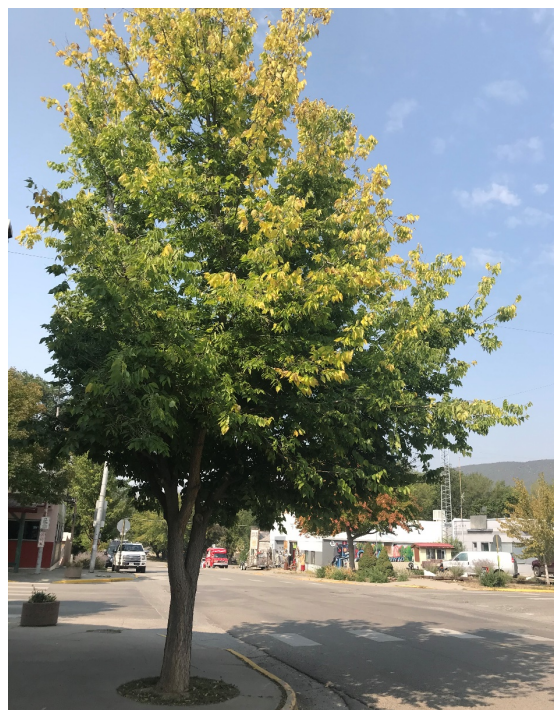
Image 13. This hackberry is located on 3<sup>rd</sup> and Grand. This will grow into a large mature tree, up to 40 ft wide by 40 ft tall. It is in the wrong location. Remove and replace with an appropriate tree species.

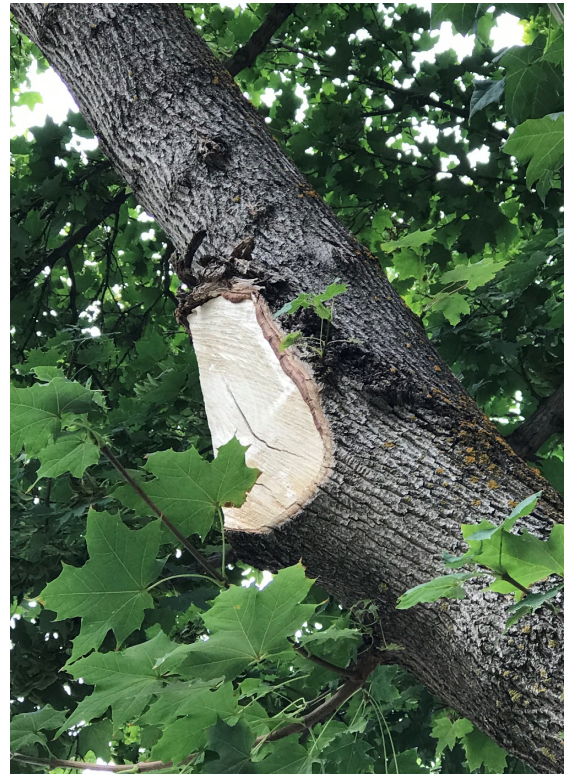
Poor pruning was observed during the inventory. This includes flush cutting of branches, leaving of branch stubs, topping of trees, tipping of tree branches, and over-pruning (removal of too much material). All of these improper practices can be avoided with training and code enforcement. Improper pruning stresses the tree unnecessarily as the tree must now close a wound that is too large or was not needed which takes resources away from basic tree functions. If the tree was topped or over pruned, it will try to replace what was removed and this can cause additional structural issues. Poorly pruned trees can also lead to disease and insect infestations or decay in branches or trunks.

Image 15. An improper pruning cut. This cut removed the bark collar and made a large wound than needed.

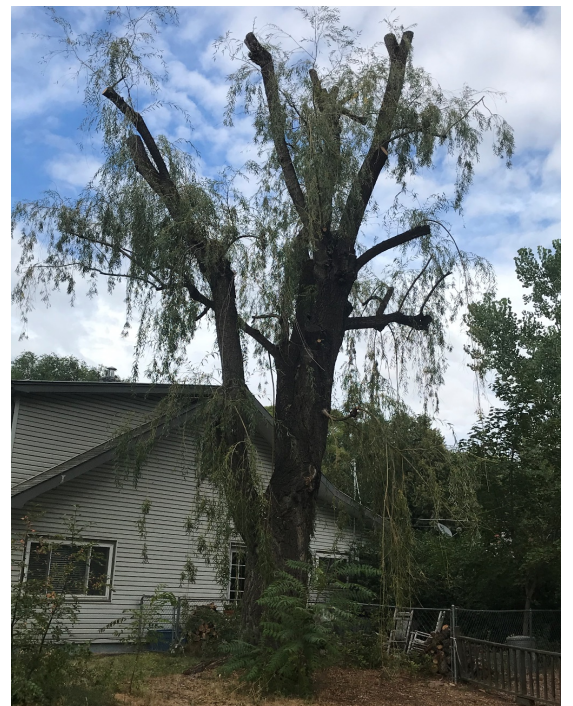
Image 16. This is a tree on private property that has been topped. This is very difficult for the tree to close the wounds and decay in the branches is likely.
