# Town of Paonia

## Street Inventory Report

January 2021  
Colorado State Forest Service

## **2020 Street Tree Inventory**

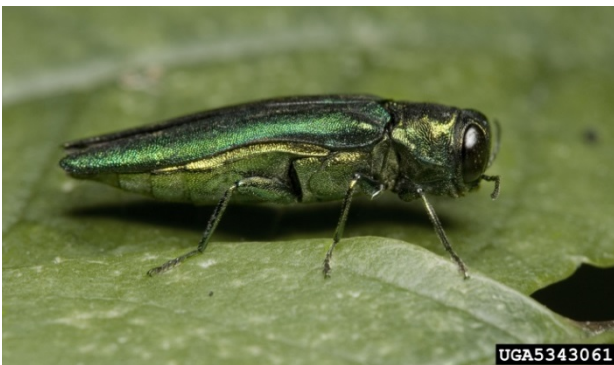
There is a non-native insect currently decimating deciduous trees in the Midwest: the Emerald Ash Borer, see Image 9, affects all species of ash (*Fraxinus*). Most likely, this insect will need a human vector to get into the urban forests of Western Colorado. It was originally detected in Boulder, Colorado and is now found in other towns and cities on the Front Range. There is no way of predicting when or if this insect will arrive in Western Colorado but because this tree species is presently growing in the Town proper, management must plan for their arrival by making the tree population as diverse as possible, as soon as possible. Mountain ash trees are not at risk, as they are in the *Sorbus* family, not in the *Fraxinus* family.

Image 9. Photo of an emerald ash borer.  
This insect will attack all species of ash.

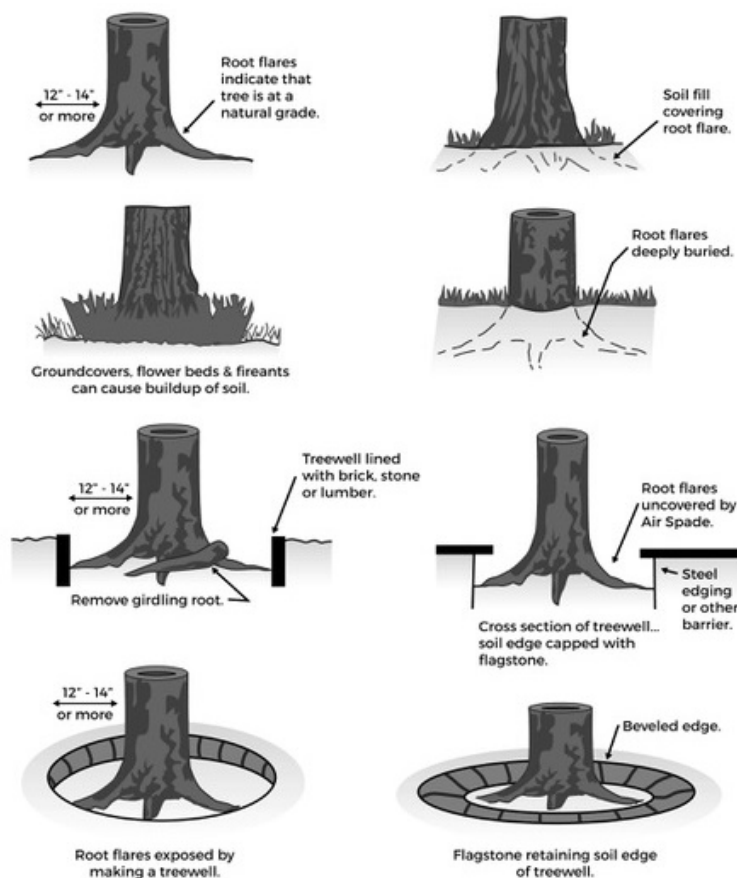
A couple of major planting issues were observed during the inventory. The first is improper planting as many newly planted street trees were planted too deep in the soil. The second issue arises from the first,

Image 14. Examples of good and bad root flares.  
Image found on dirtdoctor.com.

grass, mulch, soil, or weed barrier fabric is too close to the trunk, it could be hiding root issues or creating an environment that girdling roots can grow. Another issue is that the moisture from the soil (or mulch) can soften the tree's bark, which can allow pathogens and insects to penetrate the bark; this damage to the root flare is serious as it weakens a critical part of the tree. Additional information can be found in Appendix J and K.
